Re: Initial Site Report – Proposed Dane County Landfill Site No. 3

Dane County Department of Waste & Renewables WDNR License No. 4911, FID No. 113450480

On behalf of Dane County Department of Waste & Renewables (Dane County), Cornerstone Environmental Group - a Tetra Tech Company (Tetra Tech) is pleased to submit to the Wisconsin Department of Natural Resources (WDNR) the Initial Site Report (ISR) for the proposed Dane County Landfill Site No. 3.

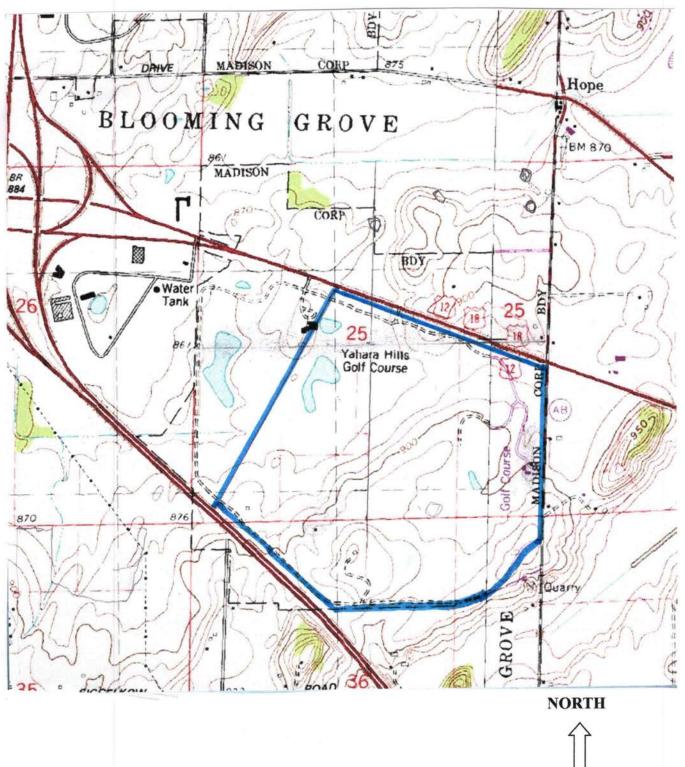
Fig. 3 – The Topography of the General Project Area

There are only limited water resources in the project area at this time. These include the two ponds in the project area and the two immediately to the west (Fig. 3). However, the ponds relate to the development of the golf course. They do not appear on the 1937 aerial photograph of the area. The ponds suggest relatively wet conditions in the area. This is supported by the soils present. Further, the 1834 G.L.O. map (Fig. 8), the 1862 plat map (Ligowsky 1862) and the 1904 U.S.G.S. map show significant marshes in the western portion of the project area.

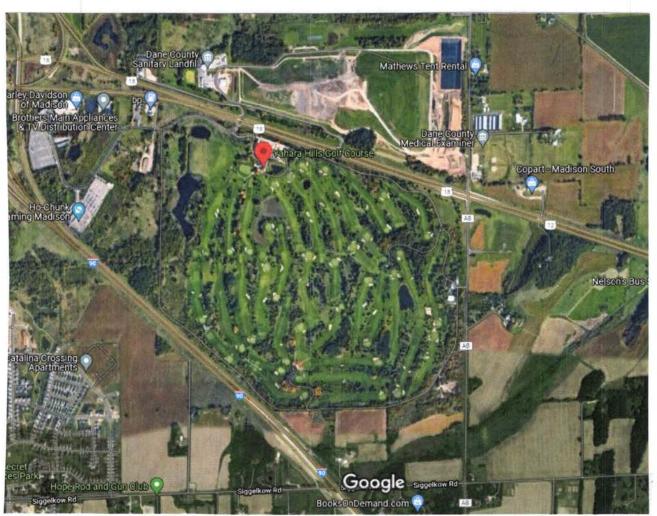
Fig. 5 – Aerial View of the Yahara Hills Golf Course

In terms of vegetation, the project area was developed as two golf courses in the 1960's. It opened as a 122 ha. (400 acre) facility in 1968. The 1939 Wisconsin Economic Inventory Map (Fig. 5) shows most of the project area in agricultural use. However, it does show an area covered by marsh grass in the NE1/4, SW1/4, Sec. 25 into the SE1/4, NW1/4, Sec. 25, T7N, R10E.

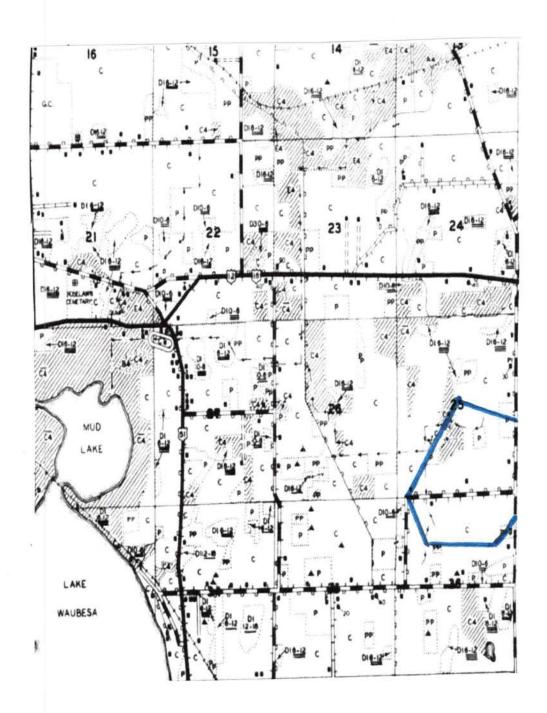
Fig. 6 – The Land Use in the General Project Area in 1939 (Wisconsin Economic Inventory Map) C – Cropland C4 – Marsh Grass

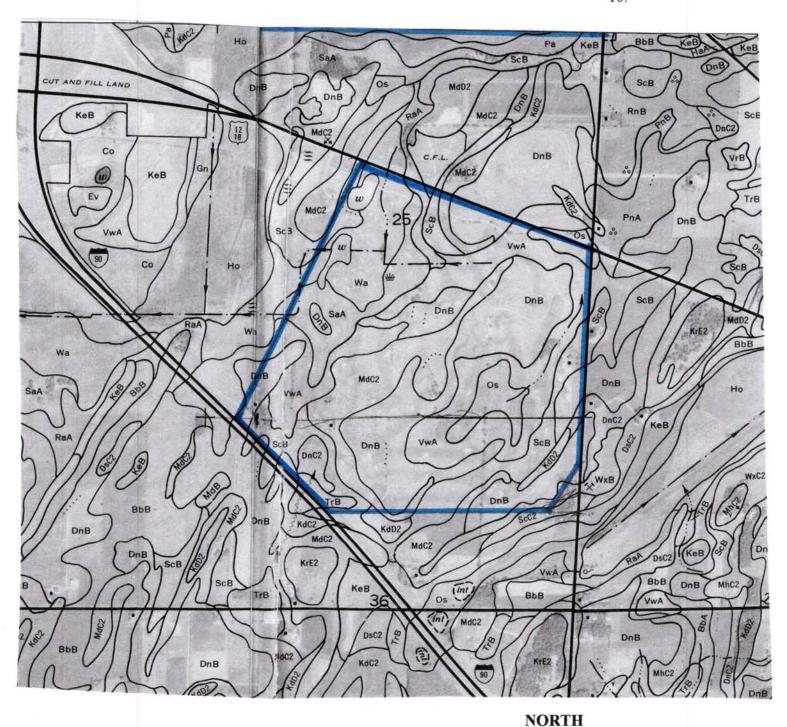
Fig. 7 – Soils in the General Project Area (Glocker and Patzer 1978)

DnB – Dodge silt loam, 2-6% slopes Or – Orion silt loam, wet VwA – Virgil silt loam, gravel substratum 0-3% slopes

The significance of these areas with somewhat poorly to poorly drained soils is that archaeological sites, especially larger occupations are less likely to be found in these locations.

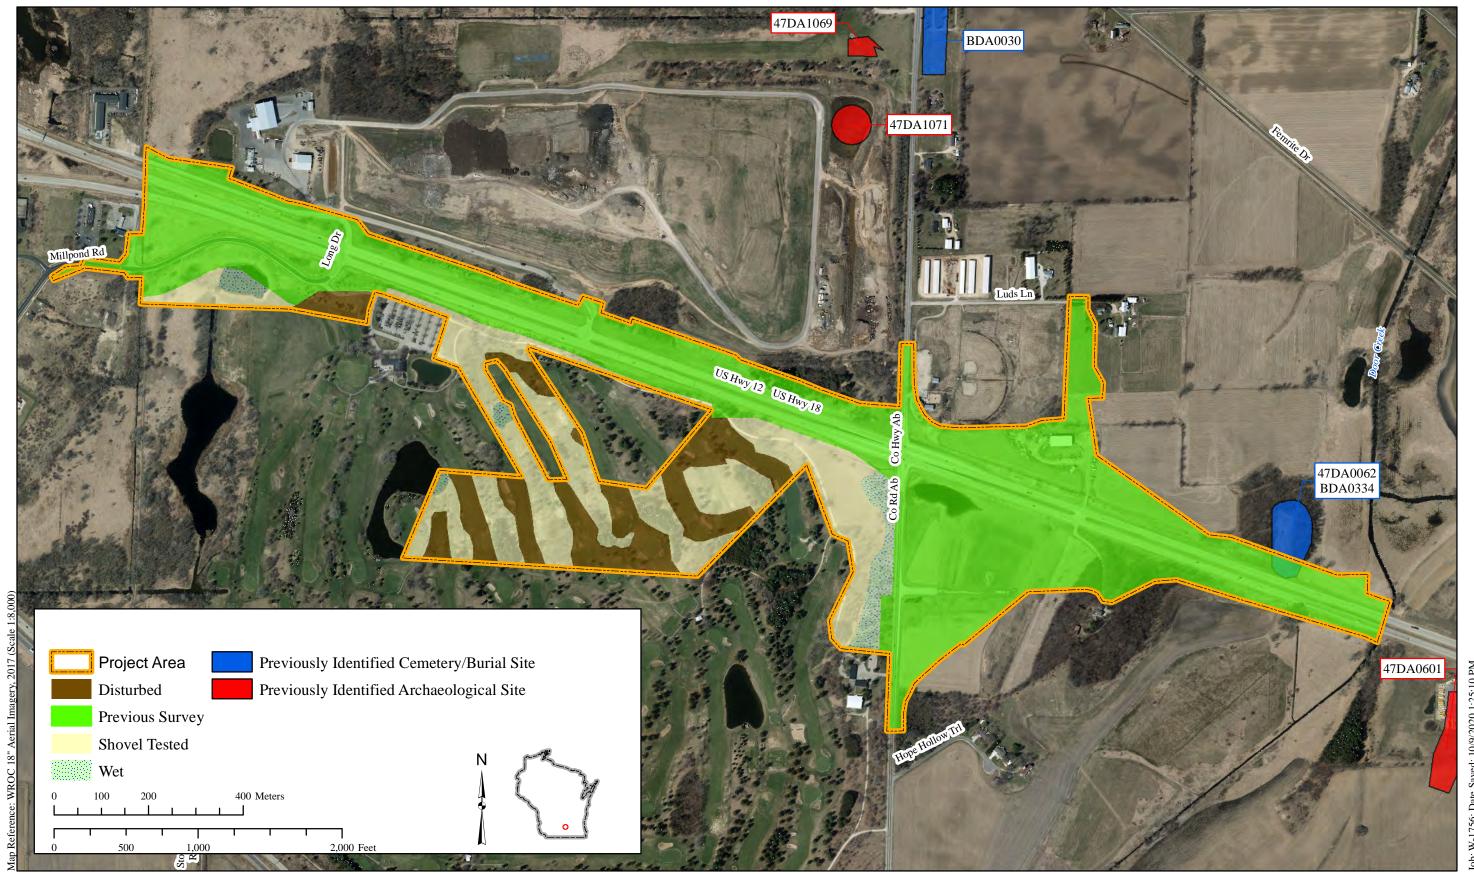
Figure 2. Project Area and Survey Coverage

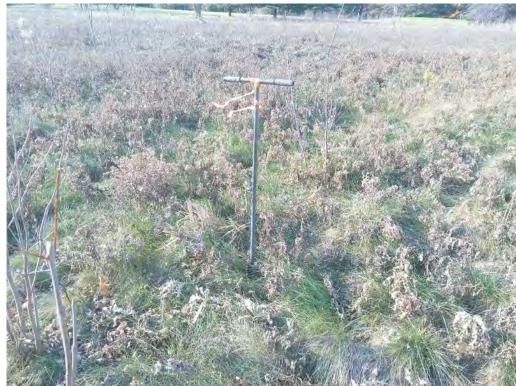
Photo of Sample Plot

-	Gleyed Matrix (S4)							Mesic Spodic (TA6) (MLRA 144A, 145, 149B)
-	Redox (S5)							Red Parent Material (F21)
	d Matrix (S6)							Very Shallow Dark Surface (TF12)
Dark Su	rface (S7) (LRR R, M	ILRA 1	49B)					Other (Explain in Remarks)
³ Indicators	of hydrophytic veg	etatior	n and wetland hyd	Irolog	y must b	e preser	nt, unless disturbe	d or problematic.
Restrictive I	Layer (if observed):							
	Type:		None			Hydric	Soil Present?	Yes <u></u> ✓ No
	Depth (inches):		NA					
Remarks:						·		
	n for hydric soil is i	met.

Southwest

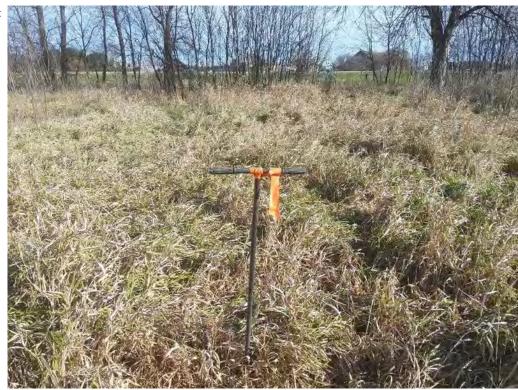
Photo of Sample Plot

-			rand Wedanu nyd	TOIOE	y must b	e preser	it, uriless disturbe	ed of problematic.
Restrictive	Layer (if observed):						5 11 B 12	V
	Type:		None			Hydric	Soil Present?	Yes No
	Depth (inches):		NA					
Remarks:								
The criterio	on for hydric soil is i	met.

Northeast

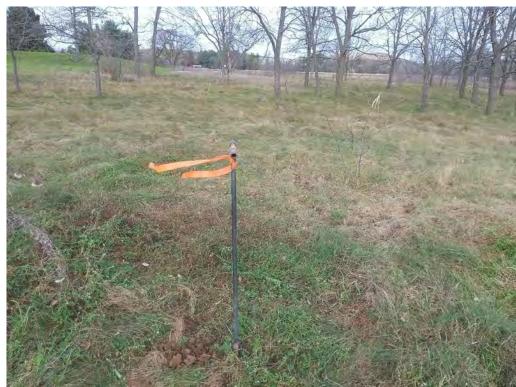
Photo of Sample Plot

-	NA			liyanc	John Frederic.	ics_	
	Depth (inches):		INA						
Remarks: The criterio	n for hydric soil is	not met.

Northwest

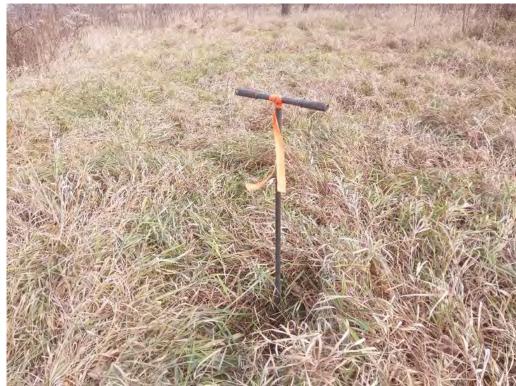
Photo of Sample Plot

Sandy	Gleyed Matrix (S4)								c (TA6) (MLRA 144A, 145, 149B)
Sandy	Redox (S5)							Red Parent I	
Strippe	d Matrix (S6)								v Dark Surface (TF12)
Dark Si	urface (S7) (LRR R, N	MLRA 14	!9B)					Other (Expla	
3Indicators	of hydrophytic veg	rotation	and wotland hyd	rolom	, must h	nrocon	t unlace disturba	•	
	Layer (if observed)		and Wetland Hyd	i olog	y iliust be	I	t, unless disturbe	ed of problematic.	
Restrictive	-	١.	Nissa			L In contract of	C-11 D		Ver (No
	Type:		None			Hyaric	Soil Present?		Yes No
	Depth (inches):		NA						
Remarks:									
The criterio	on for hydric soil is	met.							
]									
l

Northeast

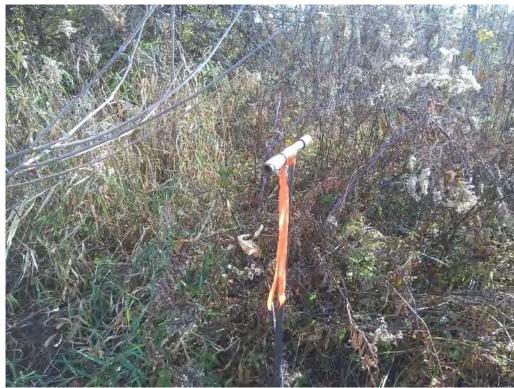
Photo of Sample Plot

-	edox (S5)							•	6) (MLRA 144A, 145, 149B)
_	Matrix (S6)							Red Parent Mate	
	rface (S7) (LRR R, N	AI DA 140)D)					Very Shallow Dar	k Surface (TF12)
Dark Su	11ace (37) (LKK K, IV	ILKA 145	76)					Other (Explain in	Remarks)
3Indicators	of hydrophytic veg	etation a	and wetland hydr	olog	y must be	e presen	t, unless disturbe	d or problematic.	
Restrictive L	ayer (if observed):		-						
	Type:		None			Hydric	Soil Present?	Yes	No
	Depth (inches):		NA	-		liyanc	John Tederic.	103	140
	Depth (inches).		INA						
Remarks: The criterion	n for hydric soil is i	not met.							
THE CHECHO	ir for flydric son is i	noc mee.

Southeast

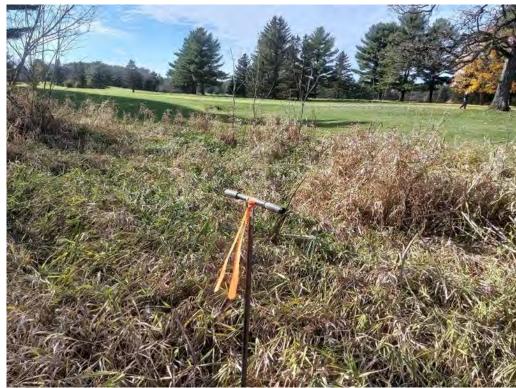
Photo of Sample Plot

-	Gleyed Matrix (S4)							Mesic S	Spodic (TA6) (MLRA 144A, 145, 149B)
_	Redox (S5)								rent Material (F21)
	d Matrix (S6)		IOD)					Very Sł	nallow Dark Surface (TF12)
Dark St	ırface (S7) (LRR R, I	MLRA 14	19B)					Other ((Explain in Remarks)
³ Indicators	of hydrophytic veg	getation	and wetland hyd	rolog	y must b	e preser	it, unless disturbe	d or probler	natic.
Restrictive	Layer (if observed)):							
	Type:		None	_		Hydric	Soil Present?	١	∕es <u> </u> No
	Depth (inches):		NA						
Remarks:		<u> </u>						·	
The criterio	on for hydric soil is	met.

West

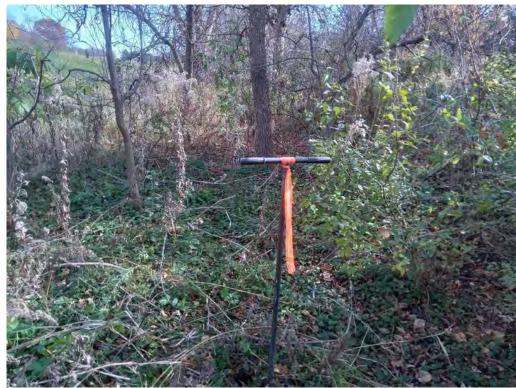
Photo of Sample Plot

-	d Matrix (S6)							Red Parent Material (F21)
	urface (S7) (LRR R, N	AI DA 140	DR)					Very Shallow Dark Surface (TF12)
Daik 3u	111ace (37) (LKK K, K	ALIXA 14:	90)					Other (Explain in Remarks)
	of hydrophytic veg		and wetland hydi	olog	y must b	e preser	nt, unless disturbe	ed or problematic.
Restrictive I	Layer (if observed):	:						
	Type:		None	_		Hydrid	Soil Present?	Yes No
	Depth (inches):		NA					
Remarks:								
The criterio	n for hydric soil is	met.

Southeast

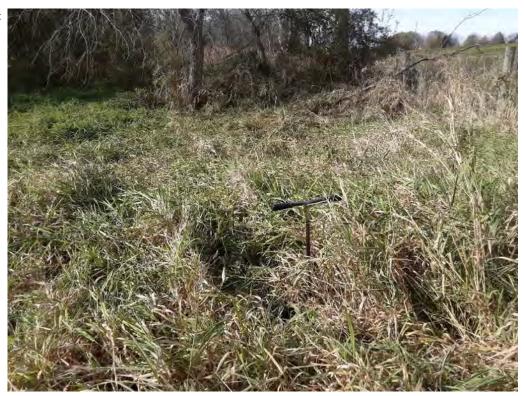
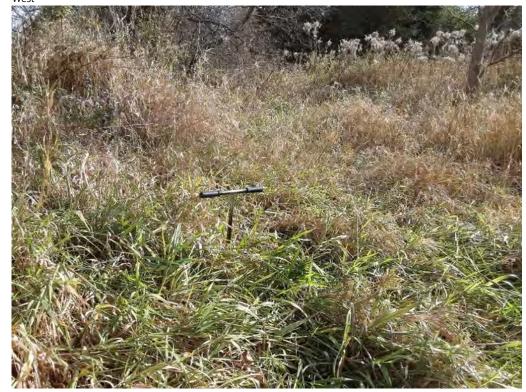
Photo of Sample Plot

-	Gleyed Matrix (S4)							Mesic Spodic (TA6) (MLRA 144A, 145, 149B)
-	Redox (S5)							Red Parent Material (F21)
	d Matrix (S6)	41 D A 1	40D)					Very Shallow Dark Surface (TF12)
Dark St	urface (S7) (LRR R, N	ILKA I	498)					Other (Explain in Remarks)
3Indicators	of hydrophytic veg	etation	n and wetland hyd	Irolog	y must b	e preser	it, unless disturbe	ed or problematic.
Restrictive	Layer (if observed):							
	Type:		None			Hydric	Soil Present?	Yes/_ No
	Depth (inches):		NA	-				
Remarks:	_	<u> </u>						
The criterio	on for hydric soil is	met.

East

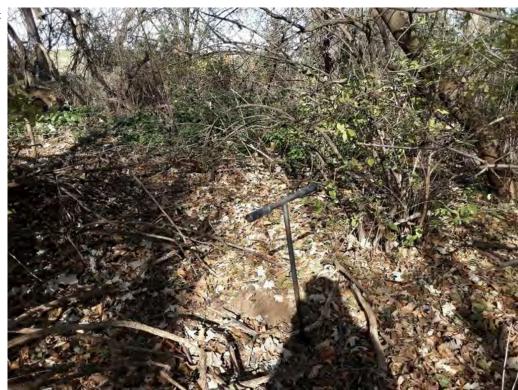
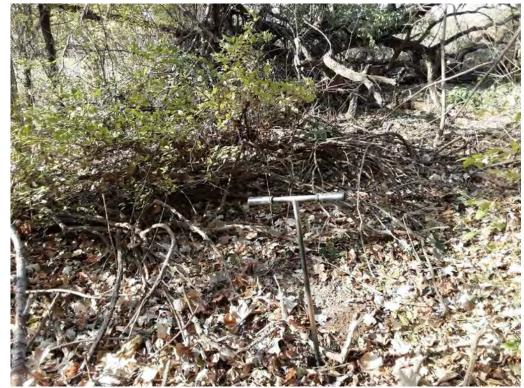
Photo of Sample Plot

Sandy 0	Gleyed Matrix (S4)							Mesic Spodic (TA6) (MLRA 144A, 145, 149B)
Sandy I	Redox (S5)							Red Parent Material (F21)
Strippe	d Matrix (S6)							
Dark Si	urface (S7) (LRR R, N	/II RA 149	9B)					Very Shallow Dark Surface (TF12)
	, (, , (,, ,		,					Other (Explain in Remarks)
³ Indicators	of hydrophytic veg	etation	and wetland hydi	olog	y must b	e presei	nt, unless disturbe	ed or problematic.
Restrictive	Layer (if observed):	:						
	Type:		None			Hydric	Soil Present?	Yes No _ ✓ _
	Depth (inches):		NA			'		
	Deptil (iliches).		INA			l .		
Remarks:	on for budric cail ic	nat mat						
The criterio	on for hydric soil is	not met.	•

North

West

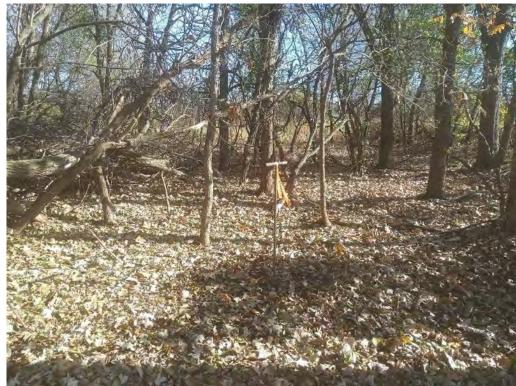
Photo of Sample Plot

Sandy F	Redox (S5)								c (TA6) (MLRA 144A, 145, 149B)
Strippe	d Matrix (S6)							Red Parent I	
	ırface (S7) (LRR R, M	ILRA 1	49B)					-	v Dark Surface (TF12)
	, ,, ,		•					Other (Expla	in in Remarks)
3Indicators	of hydrophytic veg	etatior	and wetland hyd	rolog	y must b	e preser	nt, unless disturbe	ed or problematic.	
Restrictive	Layer (if observed):								
	Type:		None			Hydric	Soil Present?		Yes No
	Depth (inches):		NA						
Remarks:						•			
	on for hydric soil is i	met.

East

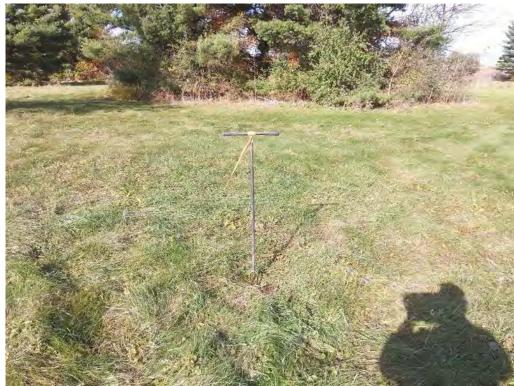
Photo of Sample Plot

-	Depth (inches):		NA						
Remarks:									
The criterio	on for hydric soil is	not met.

North

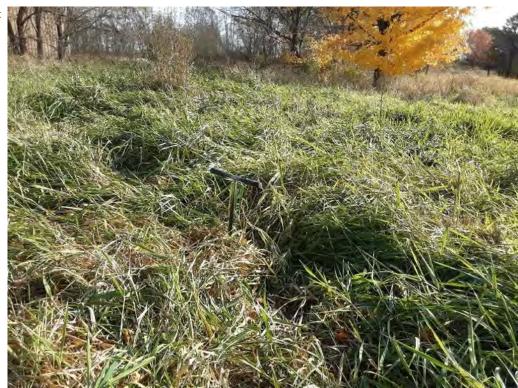
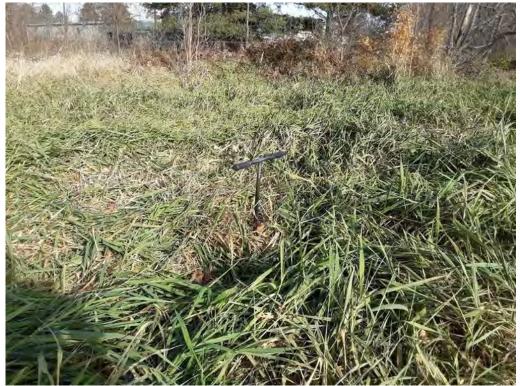
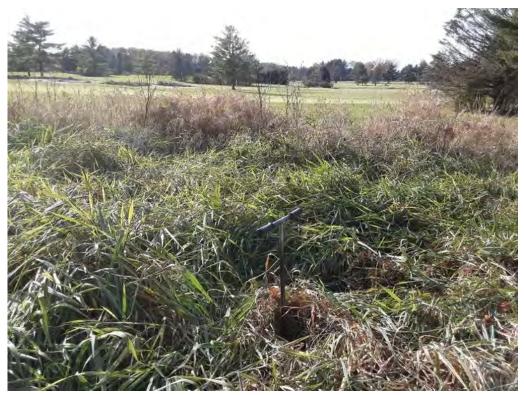
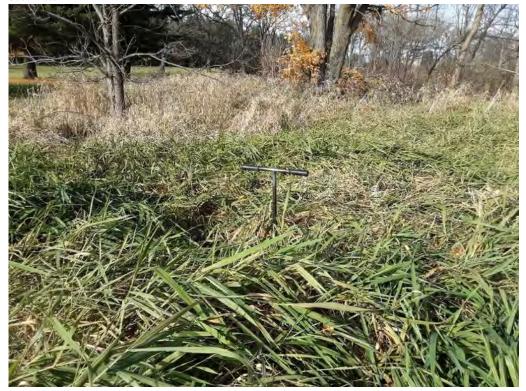
Photo of Sample Plot

-	of hydrophytic veg		and wetland hyd	rolog	y must be	presen	t, unless disturb	ed or problematic.	
Restrictive	Layer (if observed)):							
	Type:		None			Hydric	Soil Present?		Yes No
	Depth (inches):		NA						
Remarks:									
The criterio	on for hydric soil is	met.							
	,								
]

Southeast

Northeast

Southwest

North

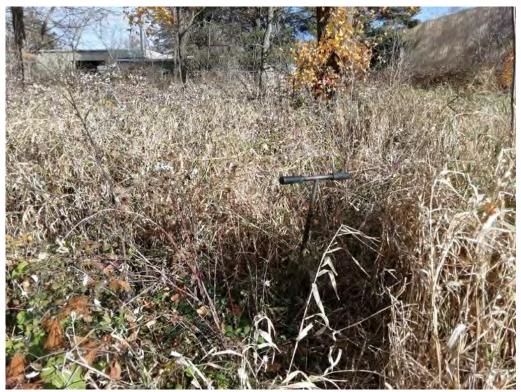
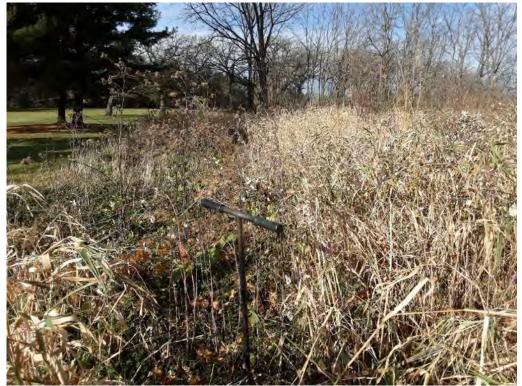
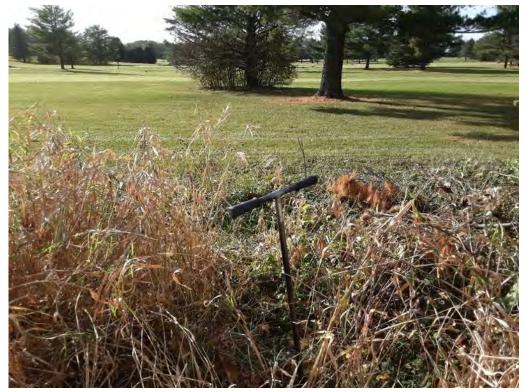
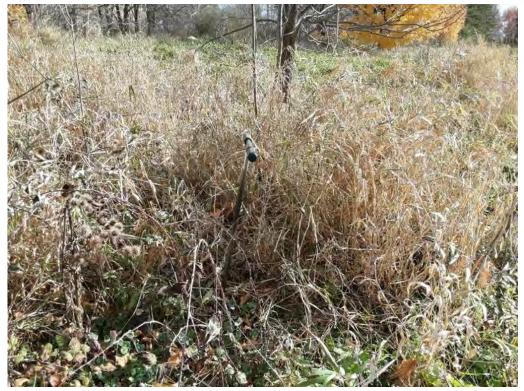
Photo of Sample Plot

-	edox (S5)								podic (TA6) (MLRA 144A, 145, 149B)
_	d Matrix (S6)								rent Material (F21)
1	rface (S7) (LRR R, N	AI DA 140	וםו					-	allow Dark Surface (TF12)
Dark Su	11ace (37) (LKK K, N	ILKA 145	, Б)					Other (Explain in Remarks)
3Indicators	of hydrophytic veg	etation a	and wetland hydr	olog	y must b	e preser	nt, unless disturbe	ed or problen	natic.
Restrictive L	ayer (if observed):	:							
	Type:		None			Hydric	Soil Present?	Yes _	No/_
	Depth (inches):		NA			-			
Remarks:	э ор от (е.тезу.					_			
	n for hydric soil is	not met.

North

West

Southeast

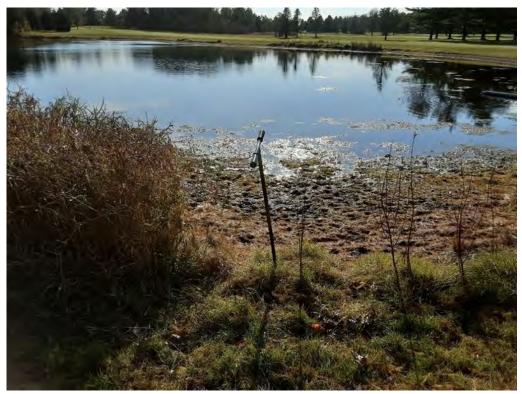
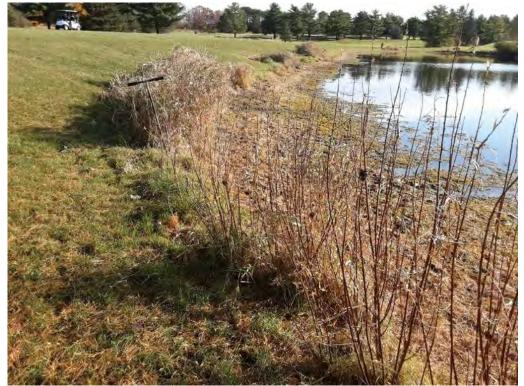
Photo of Sample Plot

-	edox (S5)							Mesic Spodic (TA6) (MLRA 144A, 145, 149B)
-	l Matrix (S6)							Red Parent Material (F21)
			OD)					Very Shallow Dark Surface (TF12)
Dark Sui	rface (S7) (LRR R, M	LKA 14	98)					Other (Explain in Remarks)
	of hydrophytic vege	etation	and wetland hyd	rolog	y must b	e preser	nt, unless disturbe	ed or problematic.
Restrictive L	.ayer (if observed):							
	Type:		None			Hydric	Soil Present?	Yes No
	Depth (inches):		NA	_				
Remarks:								
The Criterion	n for hydric soil is n	net. Ke	iusai on focks ac	6 Inc	ies.			
<u></u>

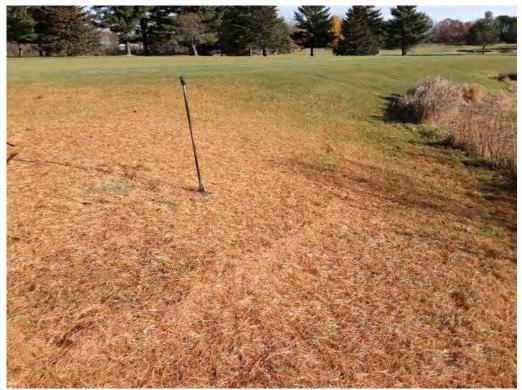
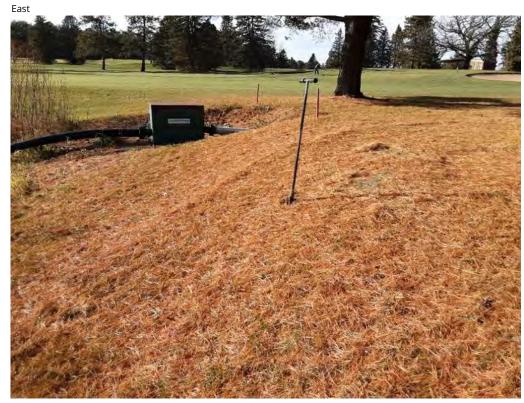
Photo of Sample Plot

-	Гуре:		None			Hydric	Soil Present?	Yes No <u>_</u> ✓
1	Depth (inches):		NA	,				
Remarks:						1		·
THE CITE IOI	n for hydric soil is i	not met.	Refusal Off IIII at	S IIIC	iles.

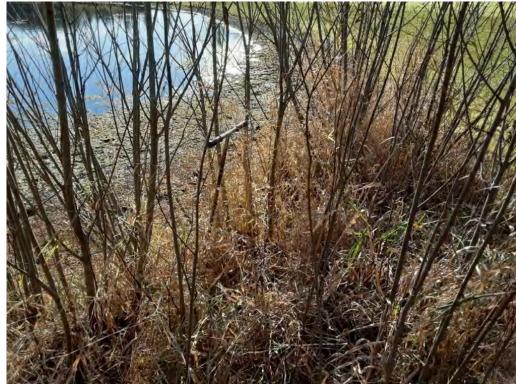
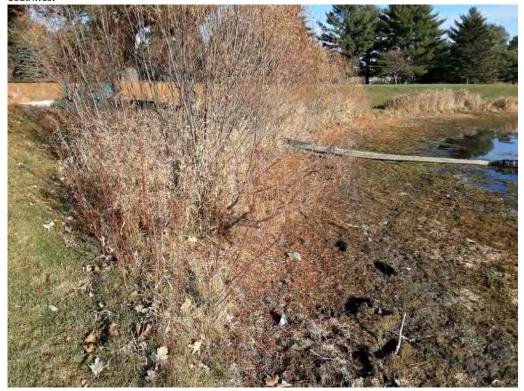
Photo of Sample Plot

Sandy Redox (S5)							Red Parent Material (F21)
Stripped Matrix (S6)							Very Shallow Dark Surface (TF12)
Dark Surface (S7) (LRR R,	MLRA 14	l9B)					Other (Explain in Remarks)
³ Indicators of hydrophytic ve	getation	and wetland hyd	rolog	y must b	e presen	t, unless disturbe	d or problematic.
Restrictive Layer (if observed)):						
Type:		None			Hydric 9	Soil Present?	Yes/_ No
Depth (inches):	_	NA	_				
Remarks:			-		ı		.
The criterion for hydric soil is	met. Re	fusal on rocks at	6 incl	nes.

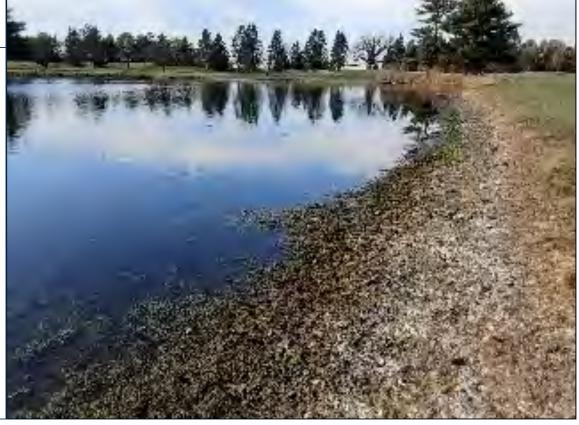
Pond P-1, facing northwest

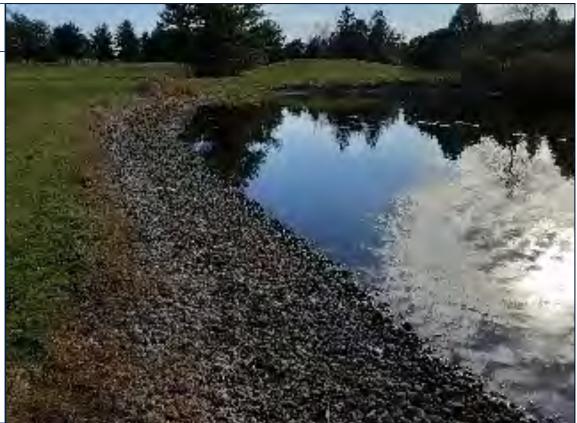
Photo No. Date 2 11/9/2021

Pond P-1 facing southeast

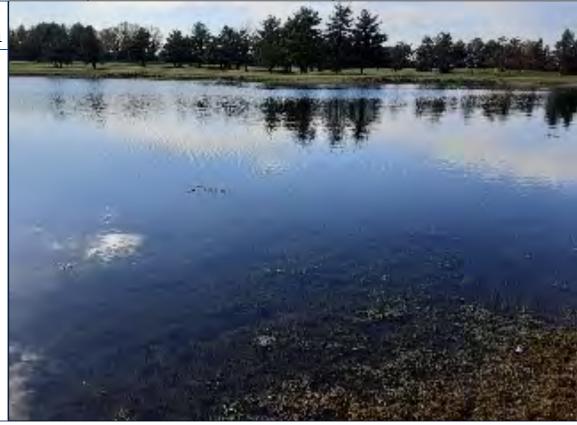
Pond P-1, facing west

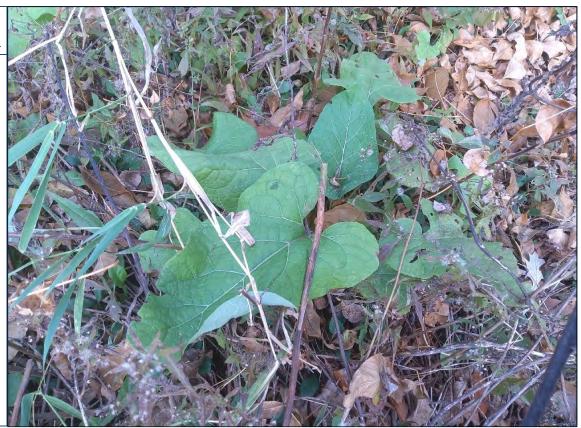
4 11/9/2021

Proof of growing season, Arctium minus (lesser burdock) and Phalaris arundinacea (reed canary grass)

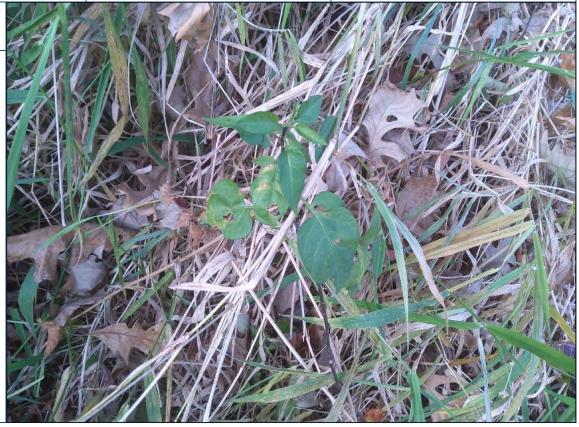
Proof of growing season,
Solanum dulcamara
(nightshade) and Phalaris
arundinacea

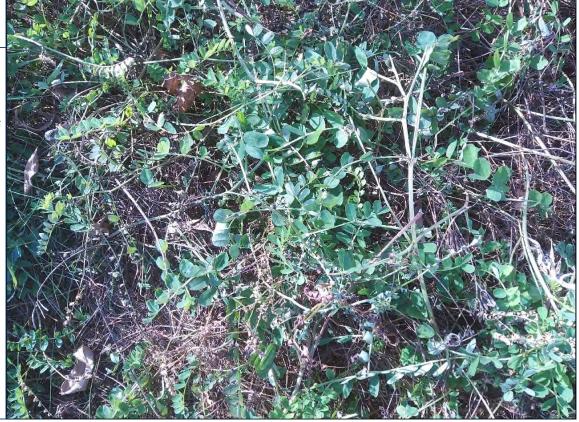
6 11/9/2021

Proof of growing season, Securigera varia (purple crown vetch) and Phalaris arundinacea (reed canary grass)

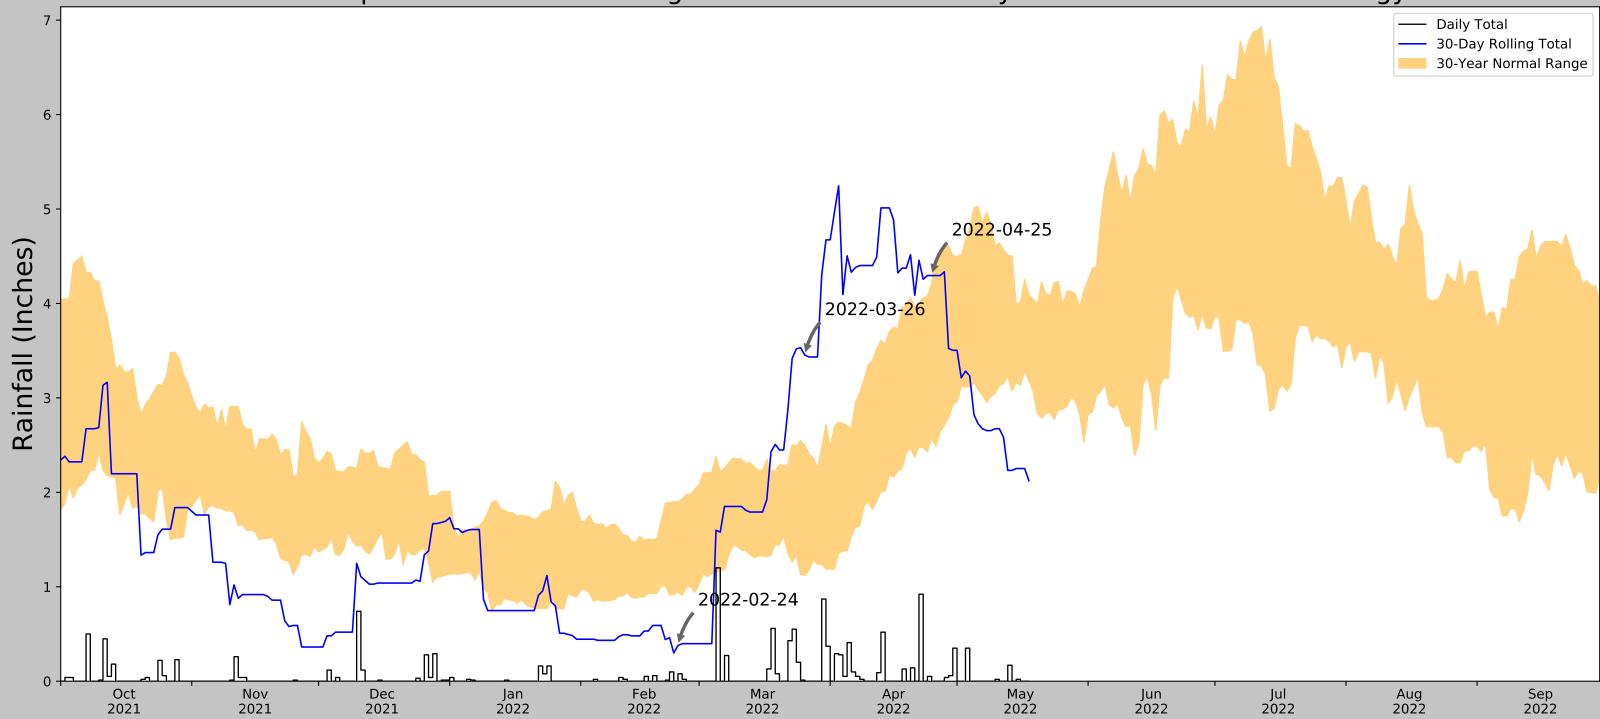
Antecedent Precipitation vs Normal Range based on NOAA's Daily Global Historical Climatology Network

Coordinates	43.041246, -89.260944
Observation Date	2022-04-25
Elevation (ft)	875.92
Drought Index (PDSI)	Moderate drought
WebWIMP H ₂ O Balance	Wet Season
